UNITED STATES ENVIRONMENTAL PROTECTION AGENCY

INSTALLATION NAME: Arcelor Mittal Burns Harbor, LLC

DATE OF RCRA INSPECTION: June 13, 14, 15, 20, 27 - 30, 2011

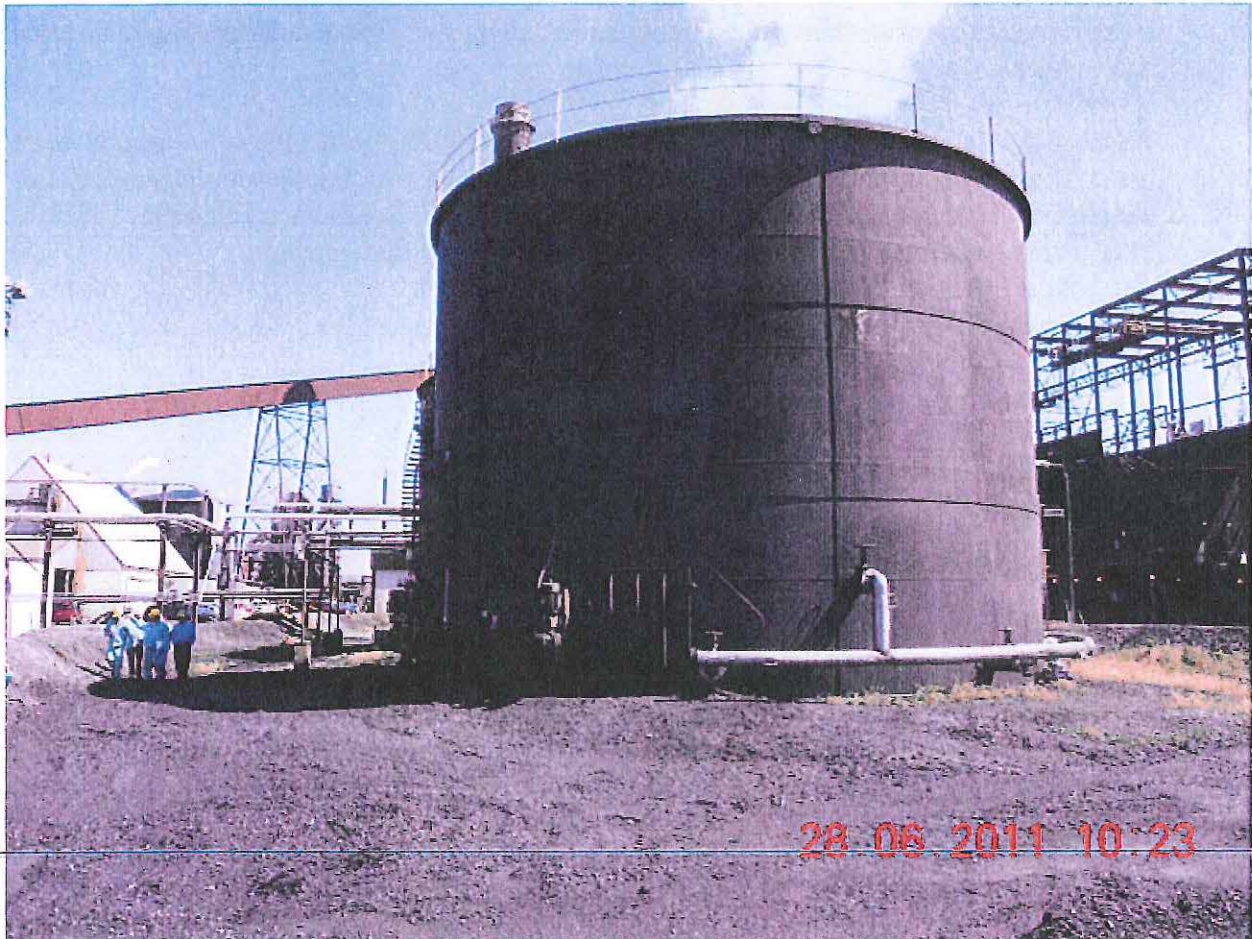
Facility: Arcelor Mittal, IND003913423
Location: 250 West US Highway 12, Burns Harbor, Indiana
Date: June 28, 2011, 10:23 a.m.
Photographer: Robert Dean Smith, LPG
Camera: Nikon Coolpix, 12.0 megapixels
Description: Photograph 1: Tar Tank C, Coke Battery area, facing N/NE

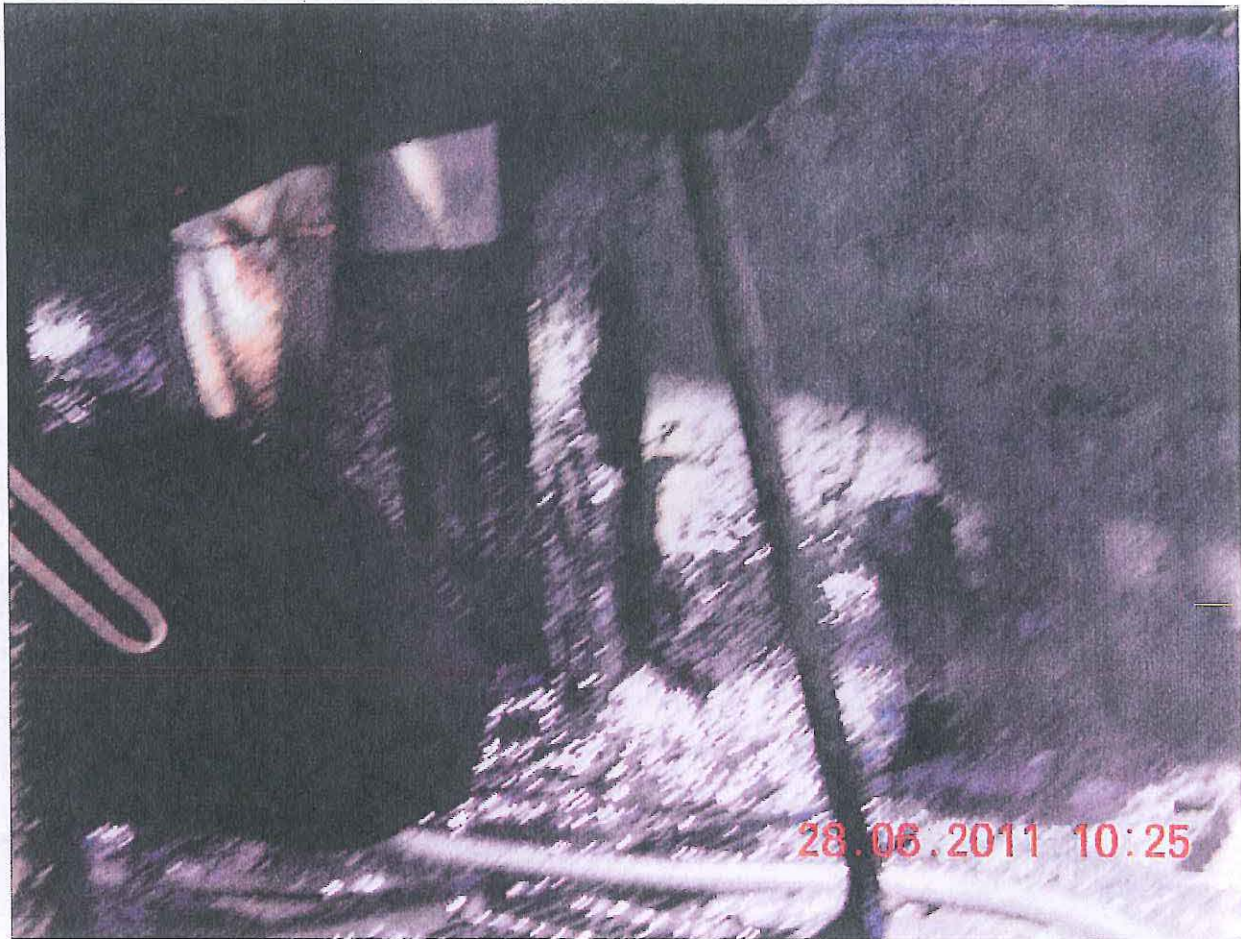
Facility: Arcelor Mittal, IND003913423
Location: 250 West US Highway 12, Burns Harbor, Indiana
Date: June 28, 2011, 10:25 a.m.
Photographer: Robert Dean Smith, LPG
Camera: Nikon Coolpix, 12.0 megapixels
Description: Photograph 2: Close up of leakage from pumps at tar tank sumps into secondary containment. Facing S/SE.

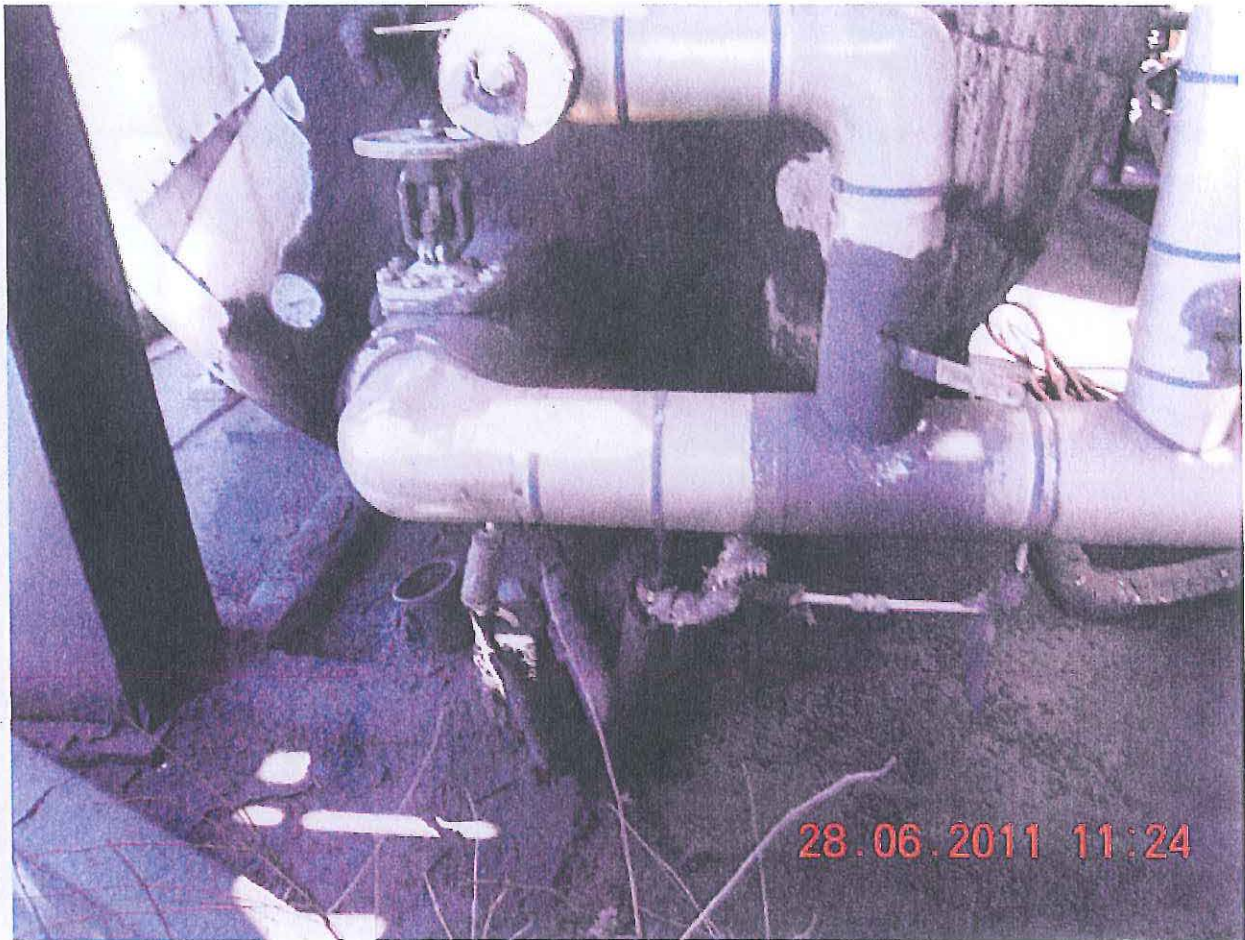
Facility: Arcelor Mittal, IND003913423
Location: 250 West US Highway 12, Burns Harbor, Indiana
Date: June 28, 2011, 11:24 a.m.
Photographer: Robert Dean Smith, LPG
Camera: Nikon Coolpix, 12.0 megapixels
Description: Photograph 10: Close up of muck oil tank. Sludge/dripping can be seen on the floor of the secondary containment. Facing W

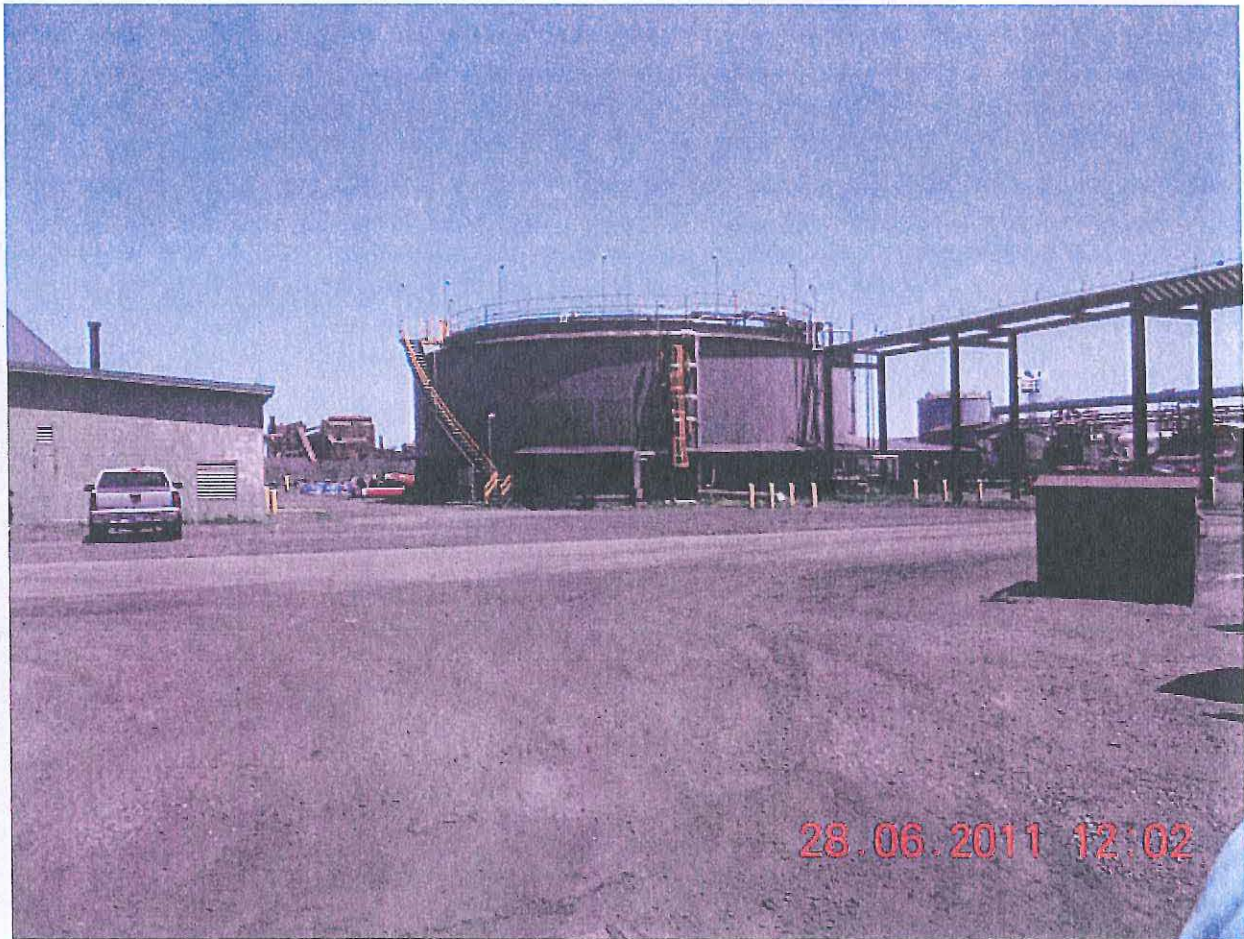
Facility: Arcelor Mittal, IND003913423
Location: 250 West US Highway 12, Burns Harbor, Indiana
Date: June 28, 2011, 12:02 p.m.
Photographer: Robert Dean Smith, LPG
Camera: Nikon Coolpix, 12.0 megapixels
Description: Photograph 20: 1,000,000 gallon tank for the ammonia flushing system. This tank is kept at half full. It contains characteristic hazardous waste. Facing N/NW.

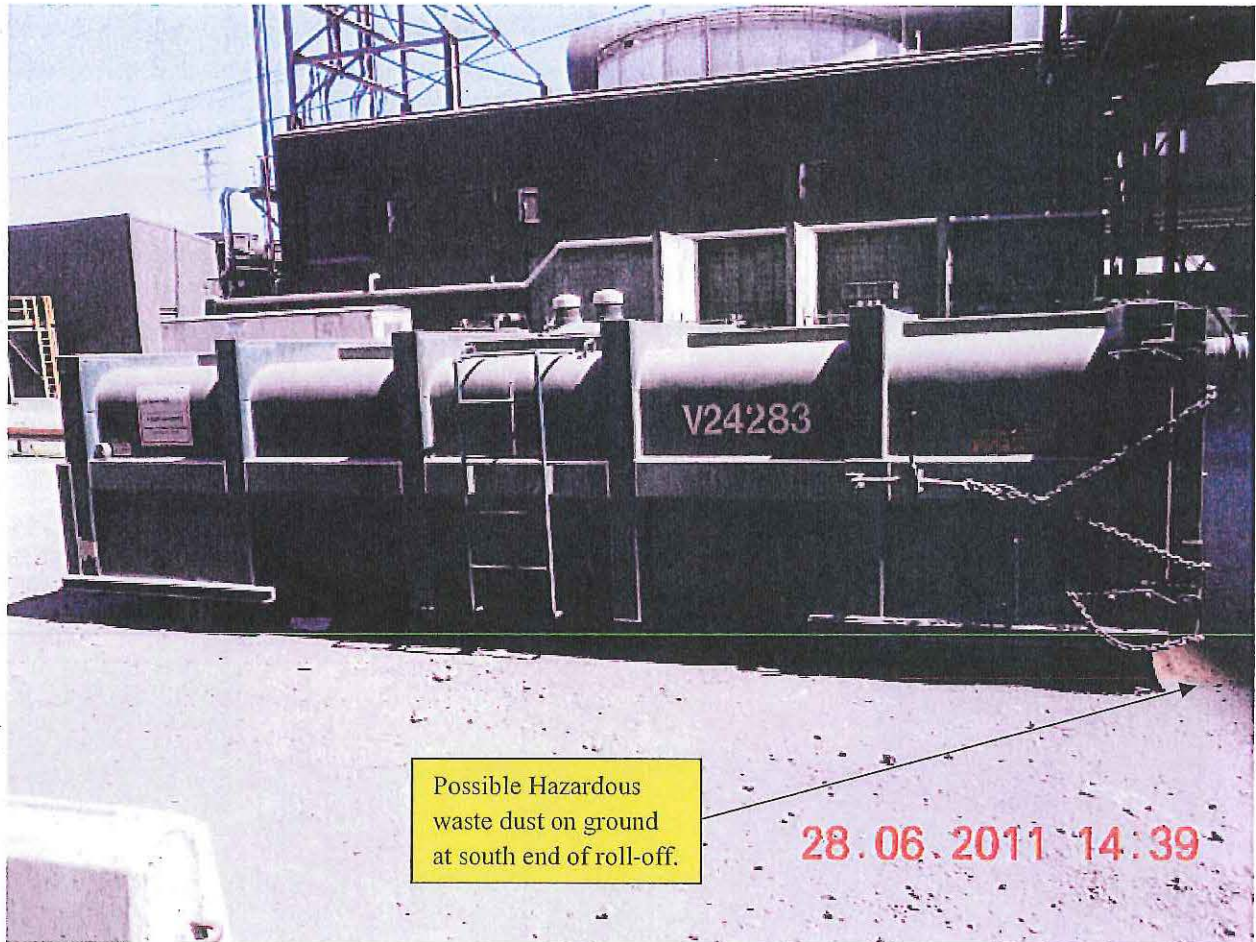
- Roll off box, operated under vacuum, collects the LTS dust, a hazardous waste (photographs 28 – 34). Photograph 29 shows a release of hazardous waste dust on the right side of the photograph. Due to the nature of the inspection, this release was actually identified two days later when EPA re-visited the site, specifically looking for releases of hazardous waste dust.

Facility: Arcelor Mittal, IND003913423
Location: 250 West US Highway 12, Burns Harbor, Indiana
Date: June 28, 2011, 2:39 p.m.
Photographer: Robert Dean Smith, LPG
Camera: Nikon Coolpix, 12.0 megapixels
Description: Photograph 29: Vacuum operated roll-off box used to collect hazardous waste dust from the bag houses located at the back end of LTS #4. A small pile of possible hazardous waste dust can be seen on right side of the roll off box. This pile of dust was actually discovered two days later when EPA returned to this area for a second inspection. It is seen clearly that the pile existed at the time of this photograph. The dust is brown or rust in color. The pile of released dust can be seen in later photographs. This vacuum roll-off box is located in the furnace area of the plant. This area is 30 degrees off of "plant north". The orientation is rotated 30 degrees to the west. Plant north is close to true north. The orientation of the vacuum roll-off box is close to NE-SW Facing E.

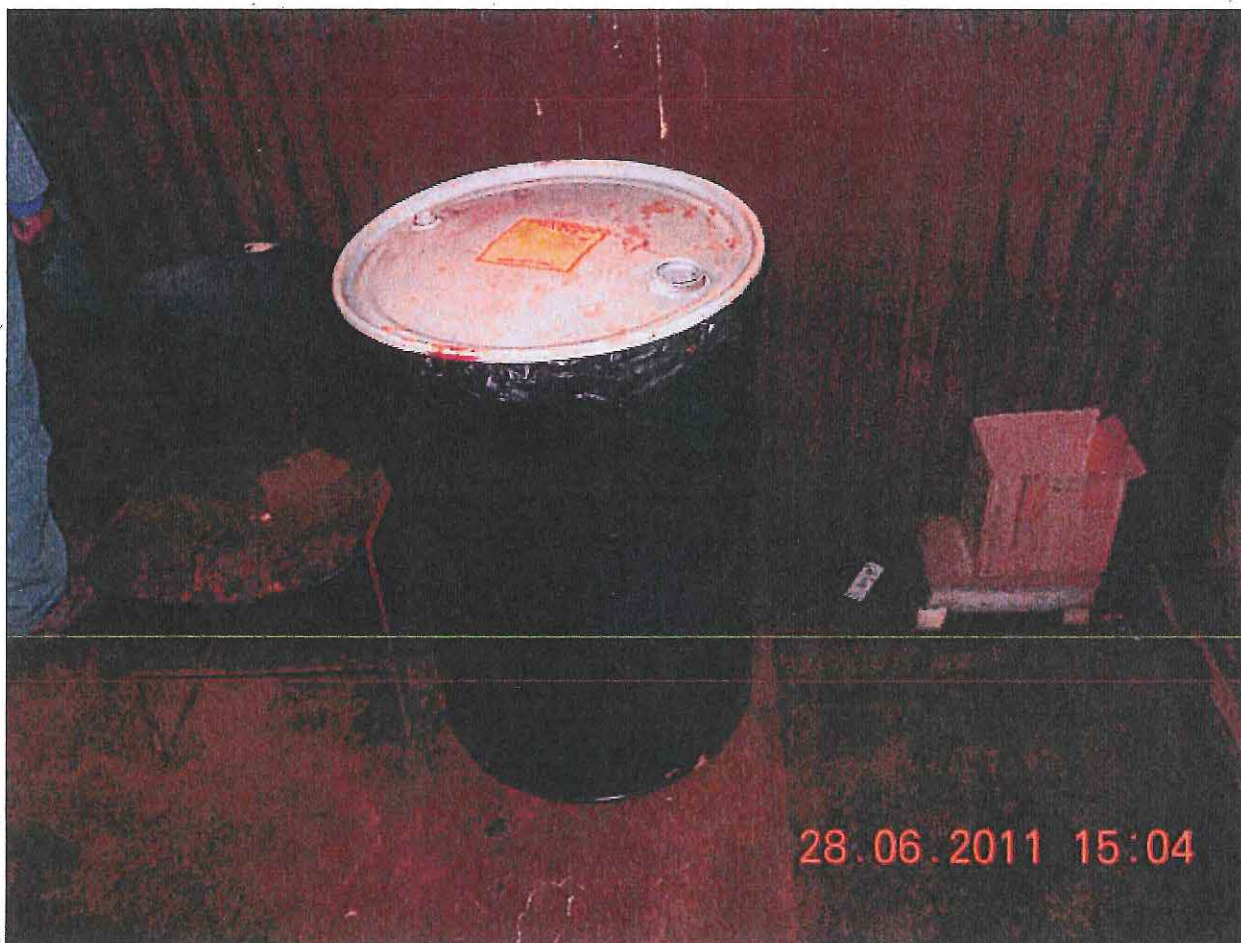
- Inspector Smith observed and photographed spent pickle liquor socks in a 55 gallon steel drum (photograph 35).
- Inspector Smith observed and photographed the spent pickle liquor storage tank. The tank has a capacity of 30,000 gallons. The tank was dated 4/22/11. Dried spent pickle liquor was observed beneath the piping associated with the tank and inside and outside the secondary containment (photographs 36 – 38).
- Inspector Smith observed and photographed a railroad tanker car that is leased to or owned by Eaglebrook in which AM fills with spent pickle liquor (photograph 39).
- Spent pickle liquor injection well number 2 (photograph 40).
- Sewer manhole at or near the spent pickle liquor tank (photograph 41 -43).

Facility: Arcelor Mittal, IND003913423
Location: 250 West US Highway 12, Burns Harbor, Indiana
Date: June 26, 2011, 3:04 p.m.
Photographer: Robert Dean Smith, LPG
Camera: Nikon Coolpix, 12.0 megapixels
Description: Photograph 35: Hazardous waste spent pickle liquor filter socks.

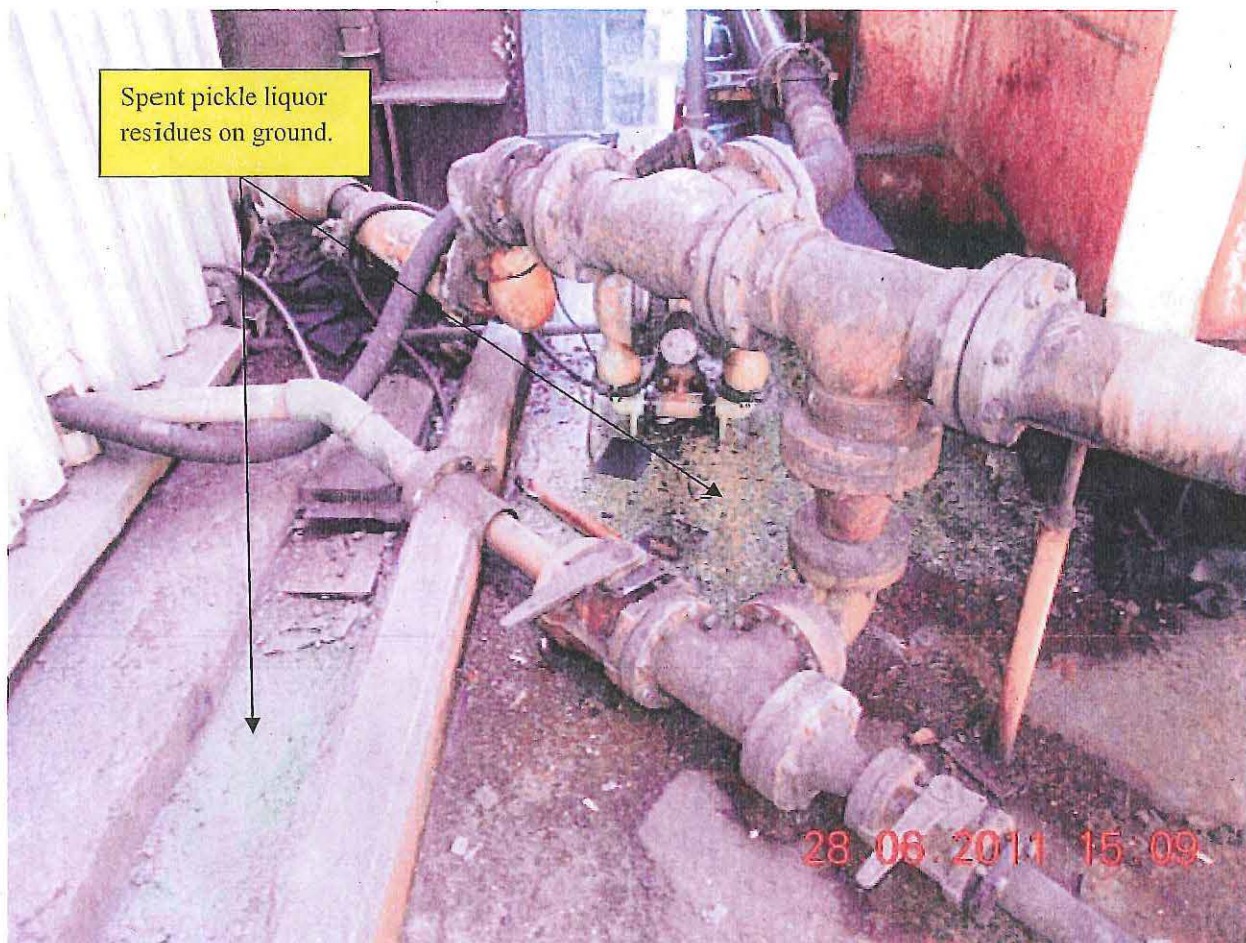
Some of the spent pickle liquor is sent down the underground injection well or some is sold to Eaglebrook. Inspector Smith observed and photographed residue from spilled spent pickle liquor adjacent to the tank. (Photos 37-38)

Facility: Arcelor Mittal, IND003913423
Location: 250 West US Highway 12, Burns Harbor, Indiana
Date: June 28, 2011, 3:09 p.m.
Photographer: Robert Dean Smith, LPG
Camera: Nikon Coolpix, 12.0 megapixels
Description: Photograph 37: Spent pickle liquor residue adjacent to the spent liquor tank. Facing W.

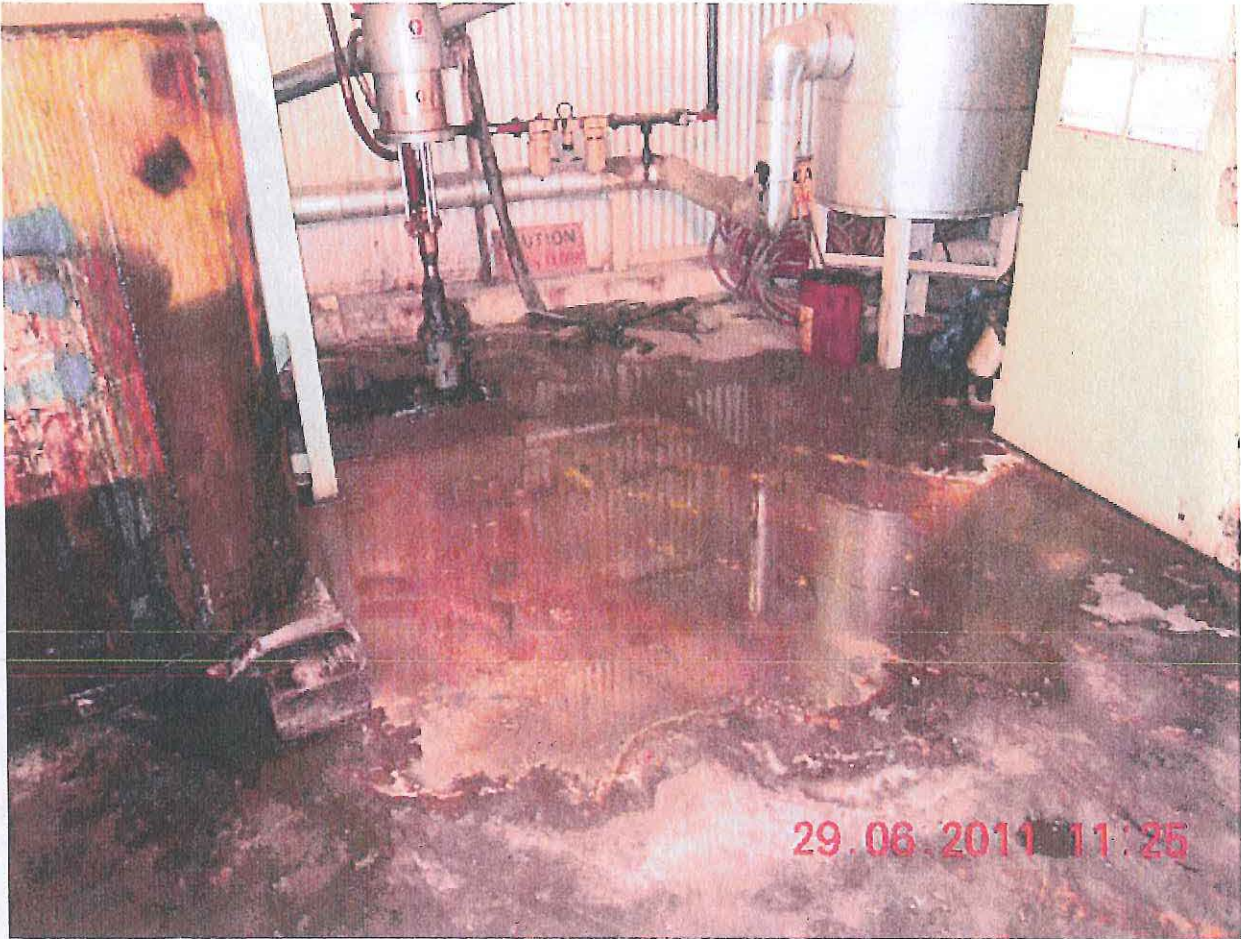
- Inspector Smith observed and photographed an area adjacent to the less than 90 day hazardous waste storage area that had water and grease on the floor (photographs 48 and 49).

Facility: Arcelor Mittal, IND003913423
Location: 250 West US Highway 12, Burns Harbor, Indiana
Date: June 29, 2011, 11:25 a.m.
Photographer: Robert Dean Smith, LPG
Camera: Nikon Coolpix, 12.0 megapixels
Description: Photograph 48: Near the less than 90 hazardous waste accumulation area, Facing south. There is a fluid on the floor as well as grease. Facing S.

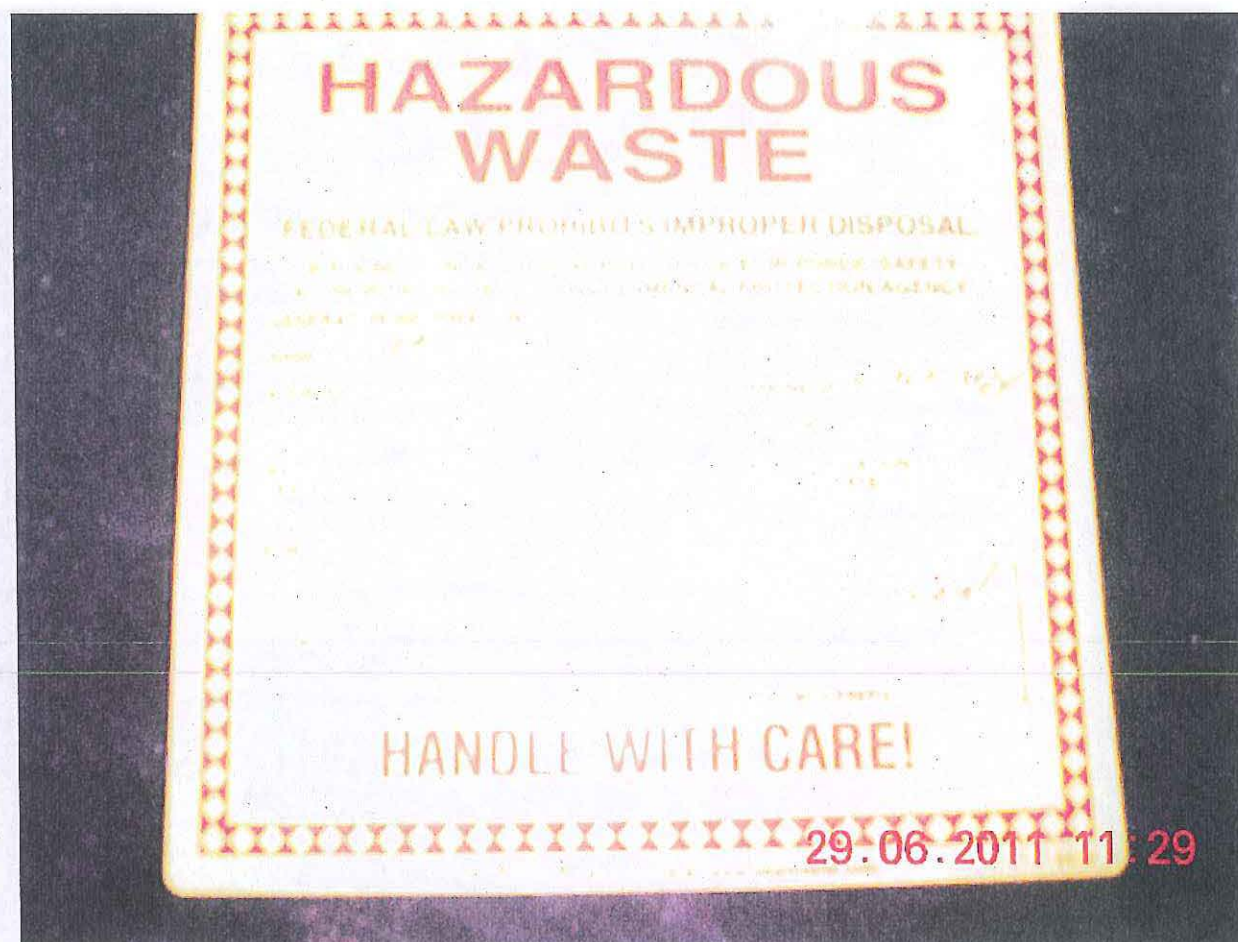
- Inspector Smith observed and photographed a satellite accumulation area in which a 55-gallon drum of waste filters was accumulating. The drum was labeled "chromate, phosphate absorbent materials" and was stored closed (photograph 51). I photographed the label of the 55-gallon drum to show there was no date of accumulation (photographs 52 and 53).

Facility: Arcelor Mittal, IND003913423
Location: 250 West US Highway 12, Burns Harbor, Indiana
Date: June 29, 2011, 11:29 a.m.
Photographer: Robert Dean Smith, LPG
Camera: Nikon Coolpix, 12.0 megapixels
Description: Photograph 52: Label for the chromate & phosphate absorbent material. Washed out and unreadable.
